Variable Valves - Plus More

**Variable Valve Timing
Plus More**

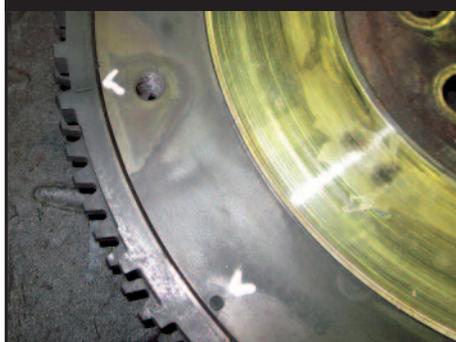
The painted arrows in this photo highlight assembly marks on the flywheel and exciter ring gear. These marks should be aligned.

As you can see clearly in the photo above, the exciter ring gear had moved. The ring gear is an interference shrink fit to the flywheel, with

The question is what could have made the exciter ring slip? After looking a little closer, it appeared there was some heat discoloration where the clutch disc contacted the flywheel. I talked with Bob and he said the clutch had been replaced twice in this vehicle. Keep in mind that it has only 65,000 miles on it. Does this indicate a problem with the pressure plate, clutch disc or the driver's habit of riding the clutch? It is unknown at this time, but it does appear excessive heat had something to do with the exciter ring movement.

what appear to be punch marks for insurance. There are no actual spot welds to hold it in place. After replacing the flywheel (the dealer had two in stock), the engine ran great again.

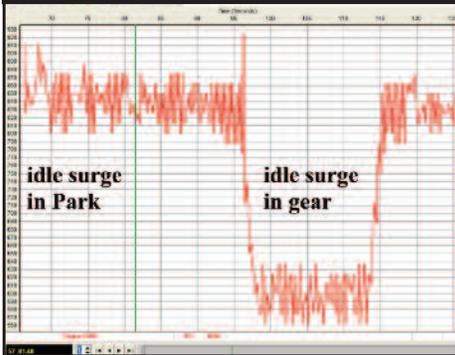
Our third case study involves a 2001 Nissan Sentra GXE, also with the 1.8L QG18DE engine found in the first two case studies. The vehicle failed an Illinois OBD II inspection for a P0335 crank sensor diagnostic trouble code (DTC). If the DTC is cleared, it resets very quickly and matures to a stored DTC. The code definition suggests that a DTC P0335 may be caused by a POS/PHASE sensor synch issue. The engine also surged at idle. Figure 1 on page 3 illustrates the idle surge in PARK and DRIVE.

Figure 1: This screen capture illustrates the Nissan Sentra idle surge.

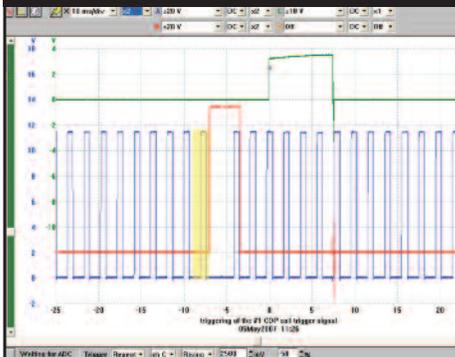
When energized, the variable valve timing system should advance the intake cam timing by 20 crankshaft degrees. However, the exhaust cam sensor waveform appears to be retarded by about 10 crank degrees. The timing chain is probably stretched, which also caused the P0355. Although the variable valve timing mechanism causes the intake camshaft to advance as it should, the intake camshaft timing also is about 20 crankshaft degrees retarded. This is probably responsible for the surge. The intake cam sprocket may have jumped a tooth, or there may be another mechanical explanation.

Figure 2: This is a known-bad pattern. The exhaust cam appears to be retarded about 10 crank degrees.

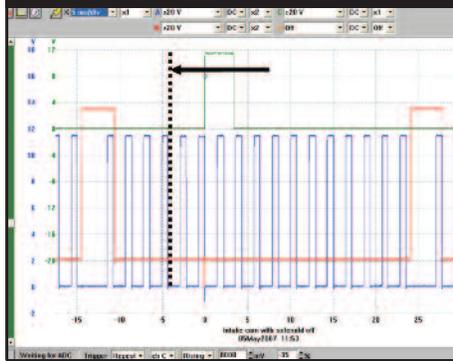
Refer to the waveforms in Figures 2 and 3 on page 3. The crank (POS) and exhaust cam (PHASE) sensor waveforms are in their usual locations, but we've added a third waveform at the top. This waveform was produced by the intake camshaft sensor.

Figure 3: The signal from the intake camshaft speed sensor should occur at the dotted line.

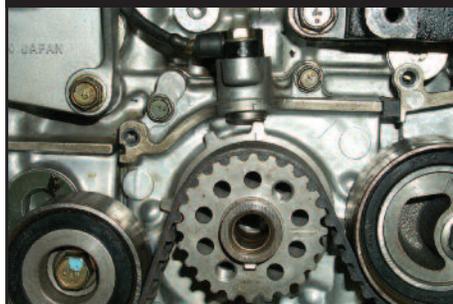
Figure 4: This crankshaft position sensor is located above a reluctor with a distinctive tooth sequence.
