Variable Valves - Plus More

**Variable Valve Timing
Plus More**

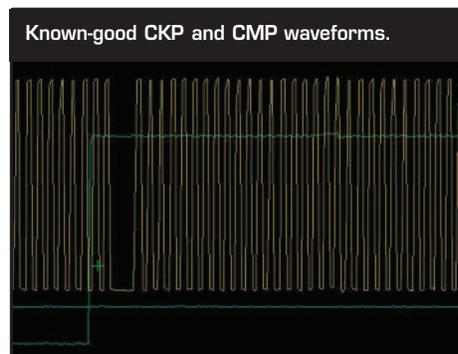
The screen capture above shows known-good crank and cam sensor patterns taken from a 2004 Kia Rio with a standard transmission. These patterns are also available on our website.
